Home Inspection Report

1 Michael Power Place
#405
Toronto, ON M9A 0A4

Date of Inspection: 04/07/2020

Inspection No. 141156-104

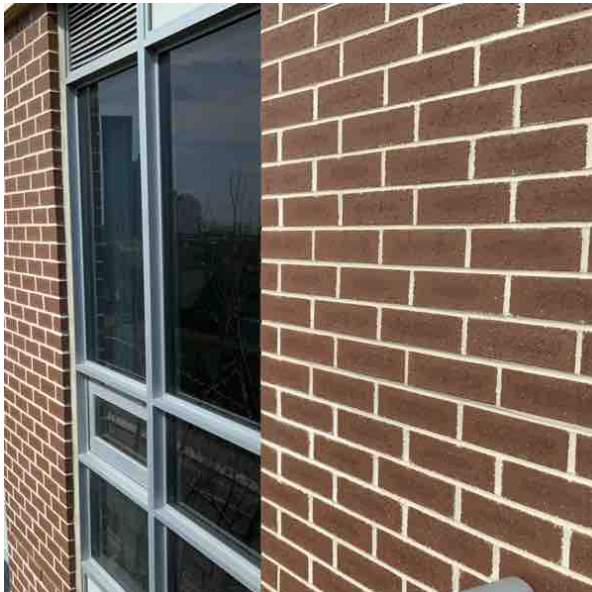
2.2 Wall Surface

2.2.1 Good condition

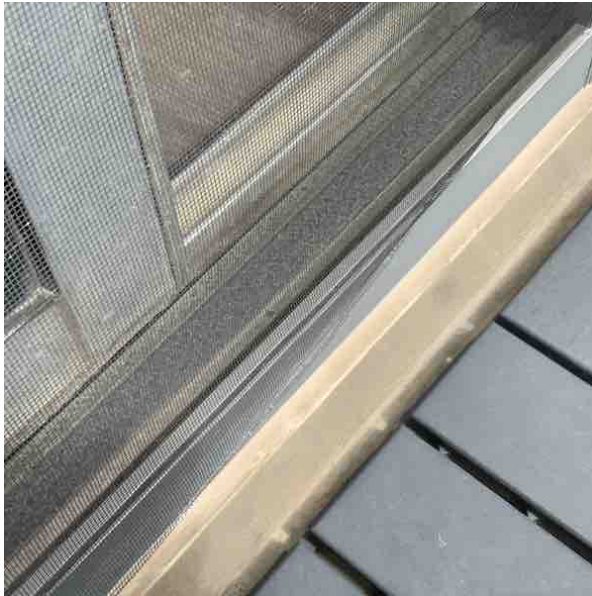
2.3 Exterior Doors

2.3.1 The screen is detached/loose at the bottom of the balcony door. Repair this to prevent damage to the screen and possible pest intrusion.

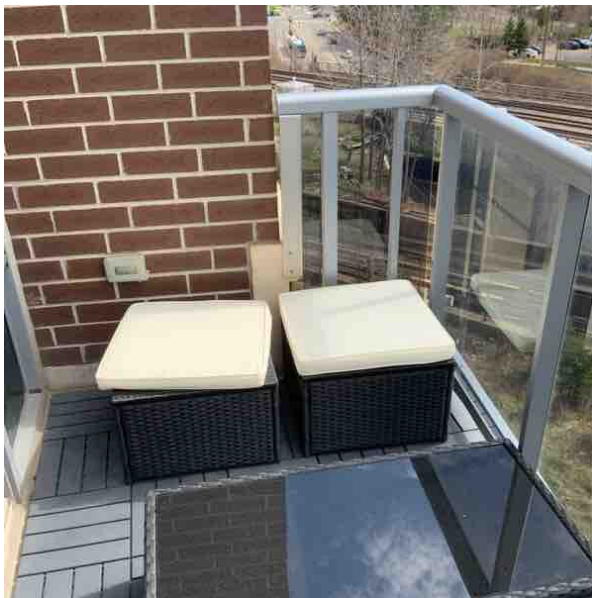
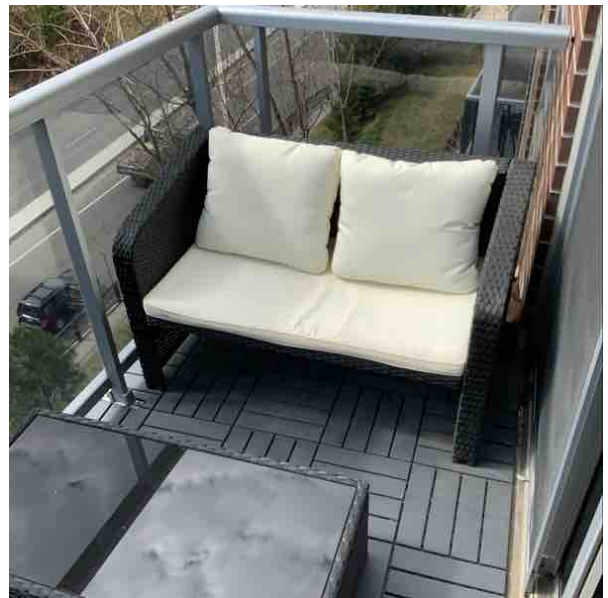
2.4 Balcony

2.4.1 Good condition

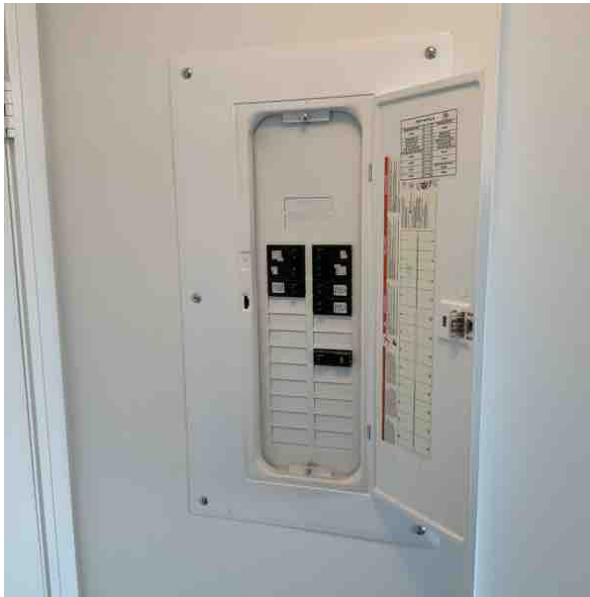
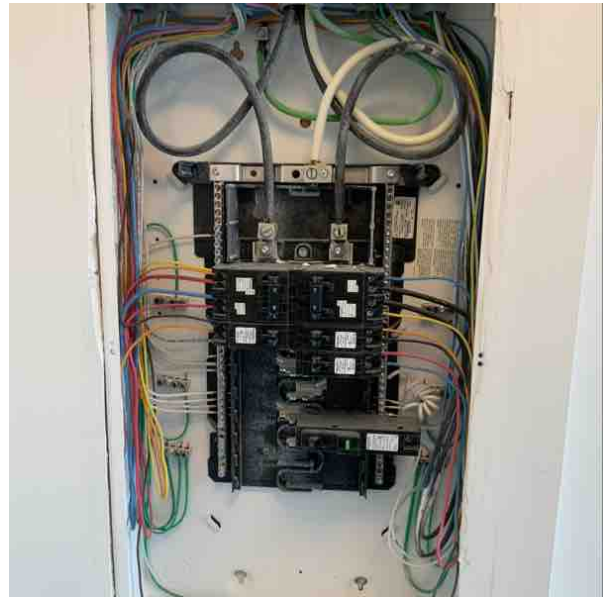
3.4 Distribution Panel(s)

3.4.1 No Significant Conditions Identified

3.4.2 Location: Behind bedroom door

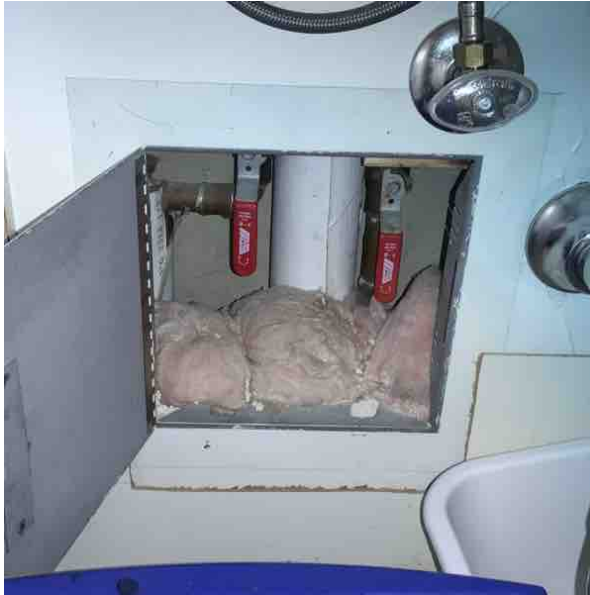
5.2 Water Main

5.2.1 No Significant Conditions Identified

5.2.2 Shut-off Location: Below bathroom sink

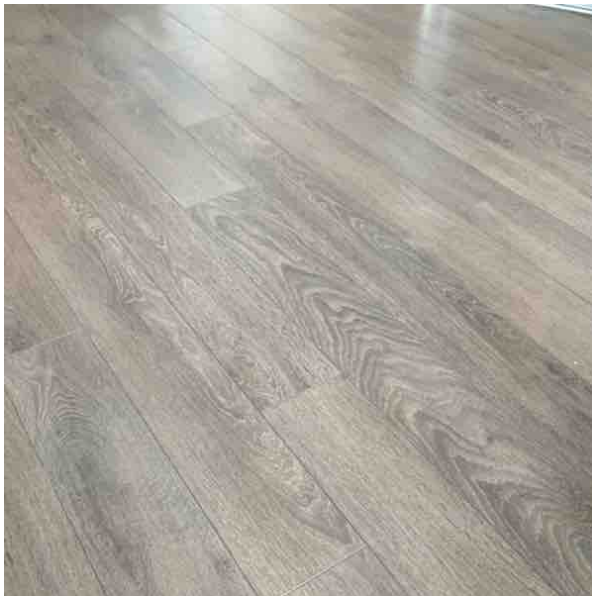
6.1 Floors

6.1.1 Good condition

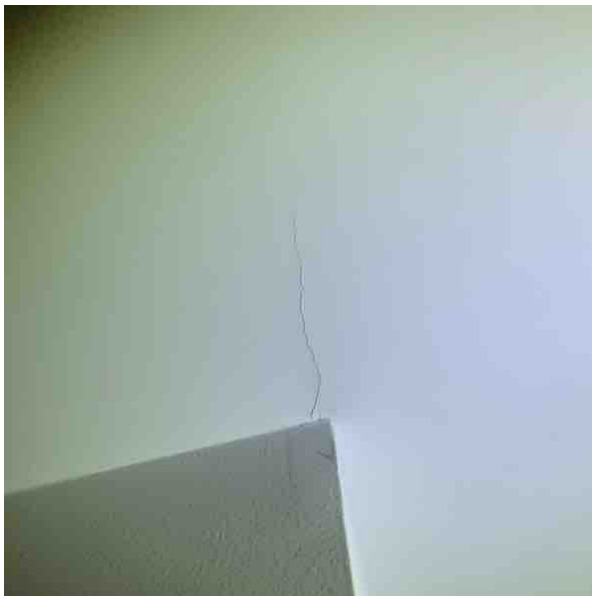
6.2 Walls / Ceilings

6.2.2 Hairline cracks at a few wall/ceiling corners are part of the natural drying process and do not pose a concern. No action necessary.
